Report No. FAA-SS-73-10

**SST Technology
Follow-On Program-Phase II**

**DEVELOPMENT AND EVALUATION
OF FUEL TANK SEALANTS**

FINAL REPORT
Task II

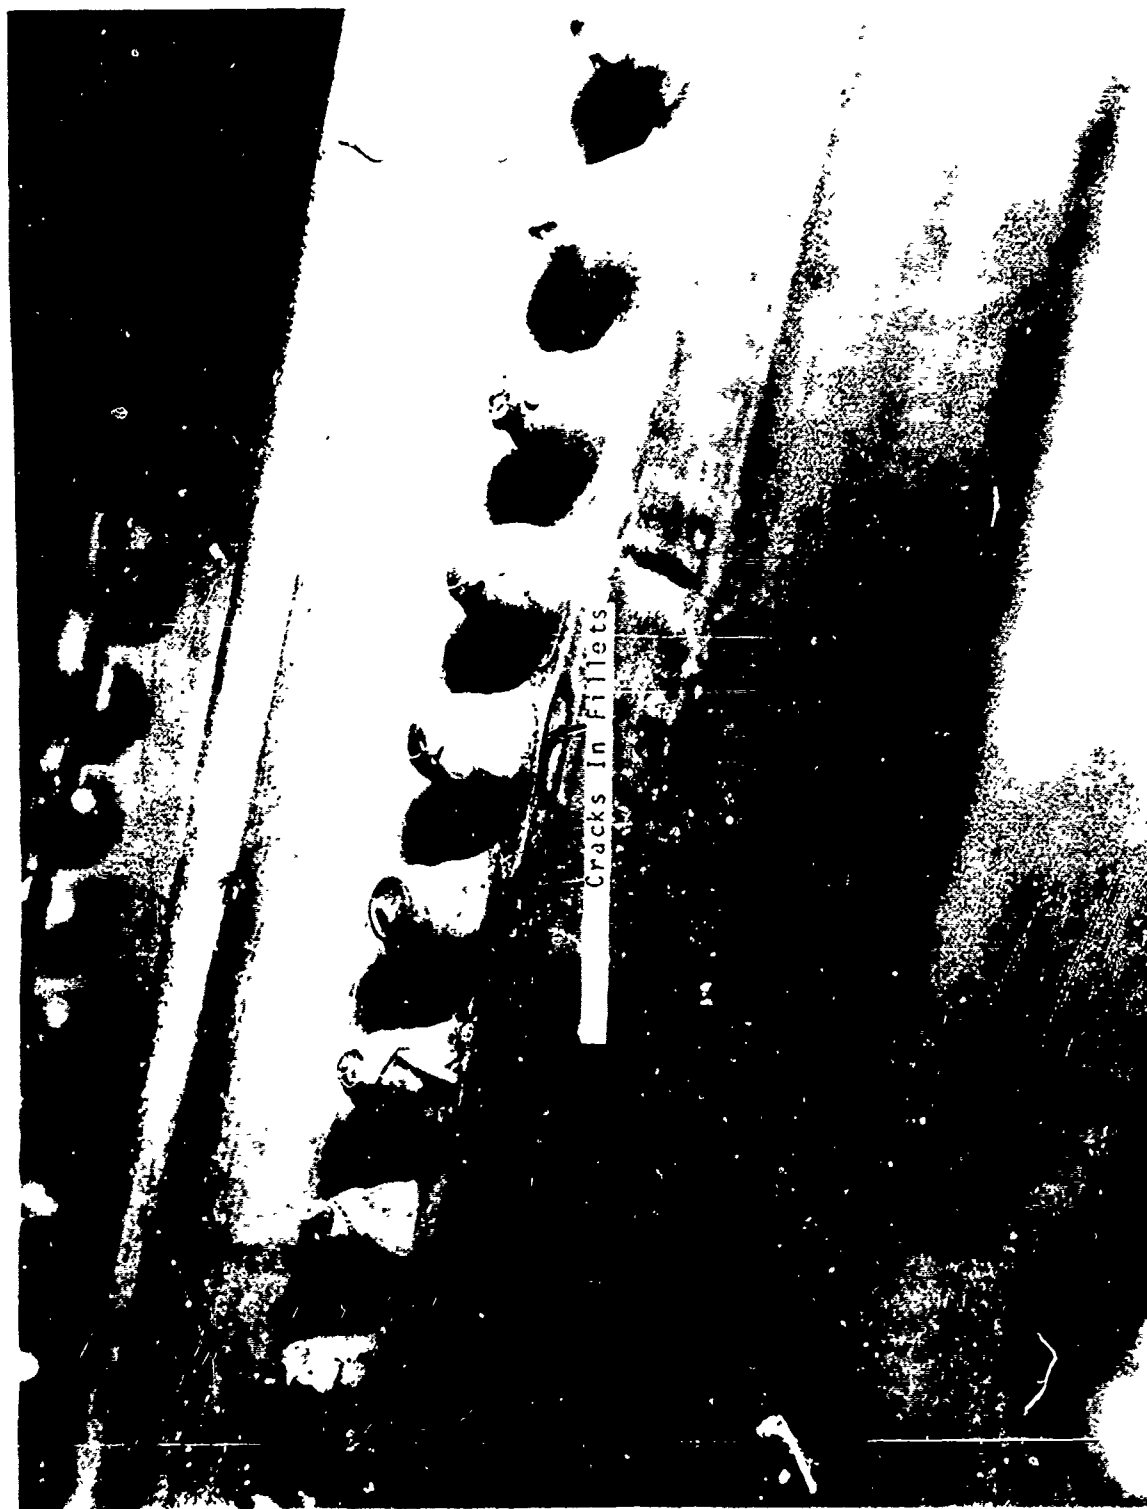
FIGURE 14 - CRACKS IN FILLETS AT BASE OF FASTENERS

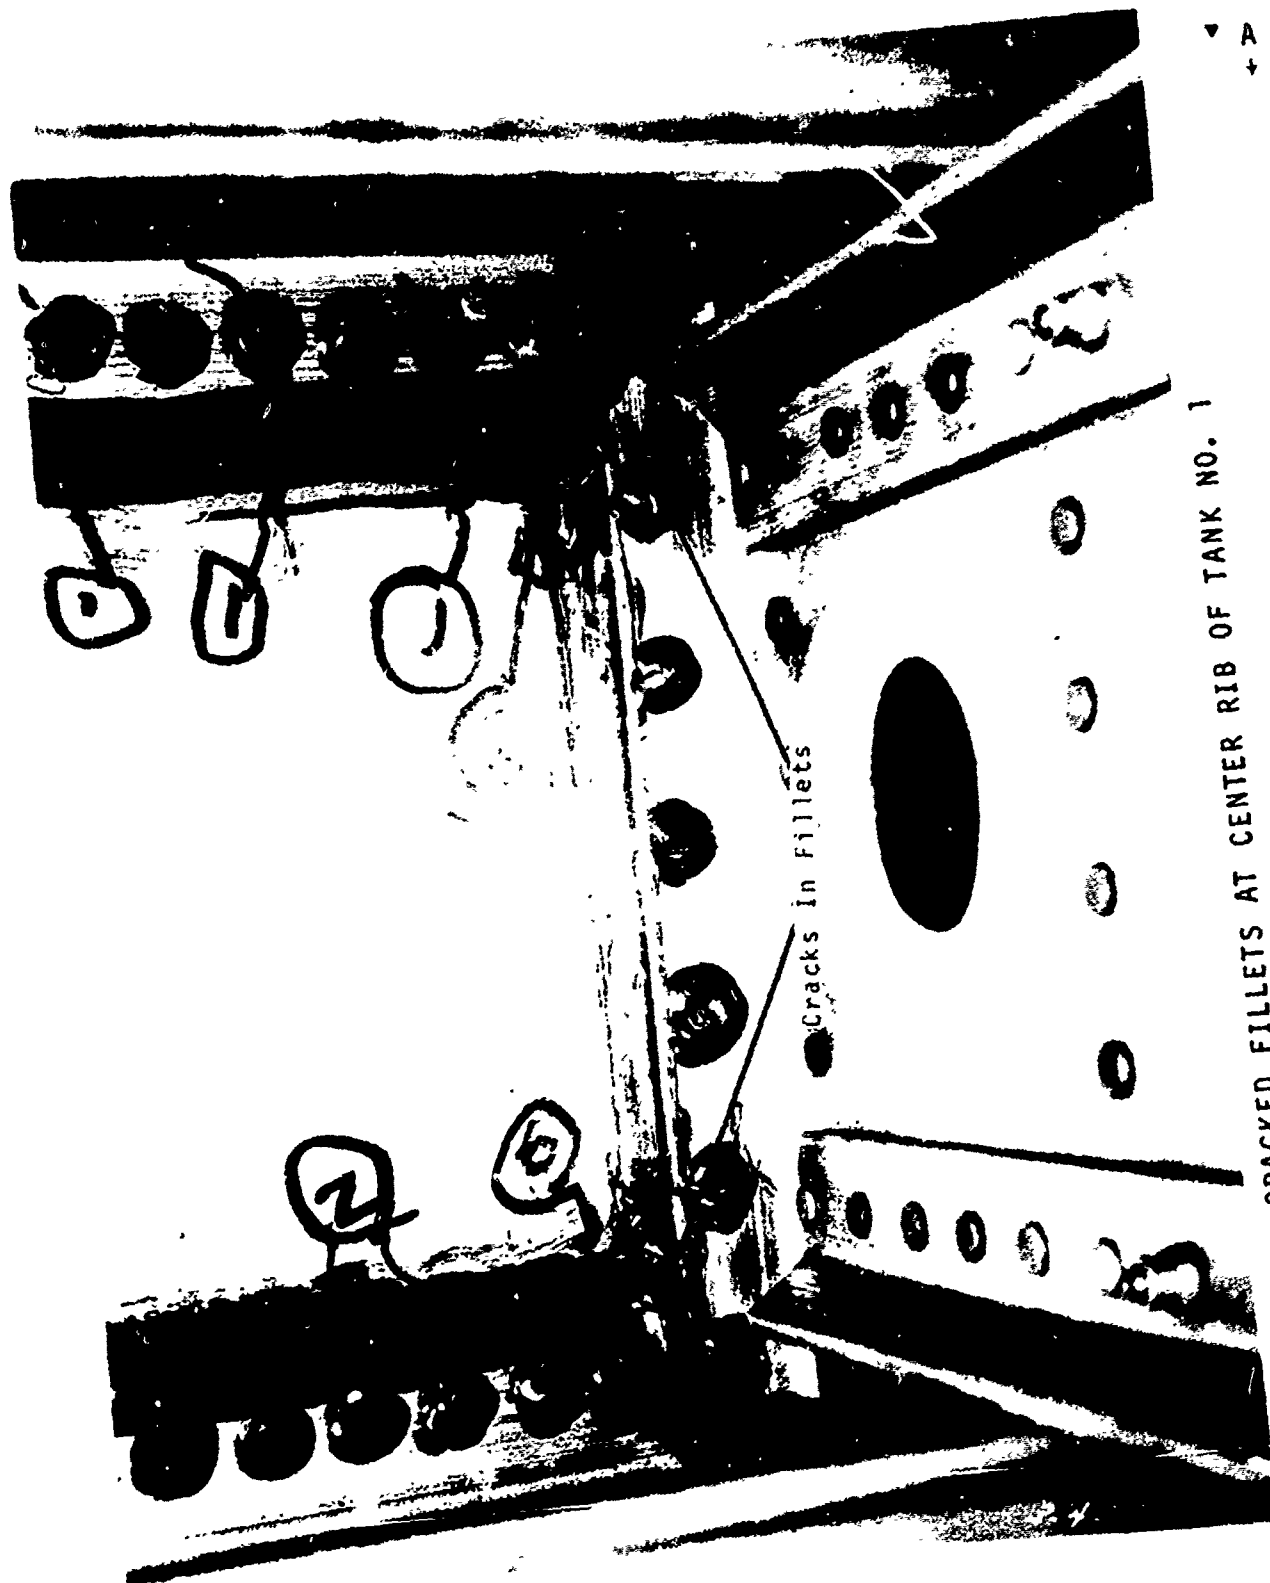
FIGURE 15 - CRACKED FILLETS AT CENTER RIB OF TANK NO. 1

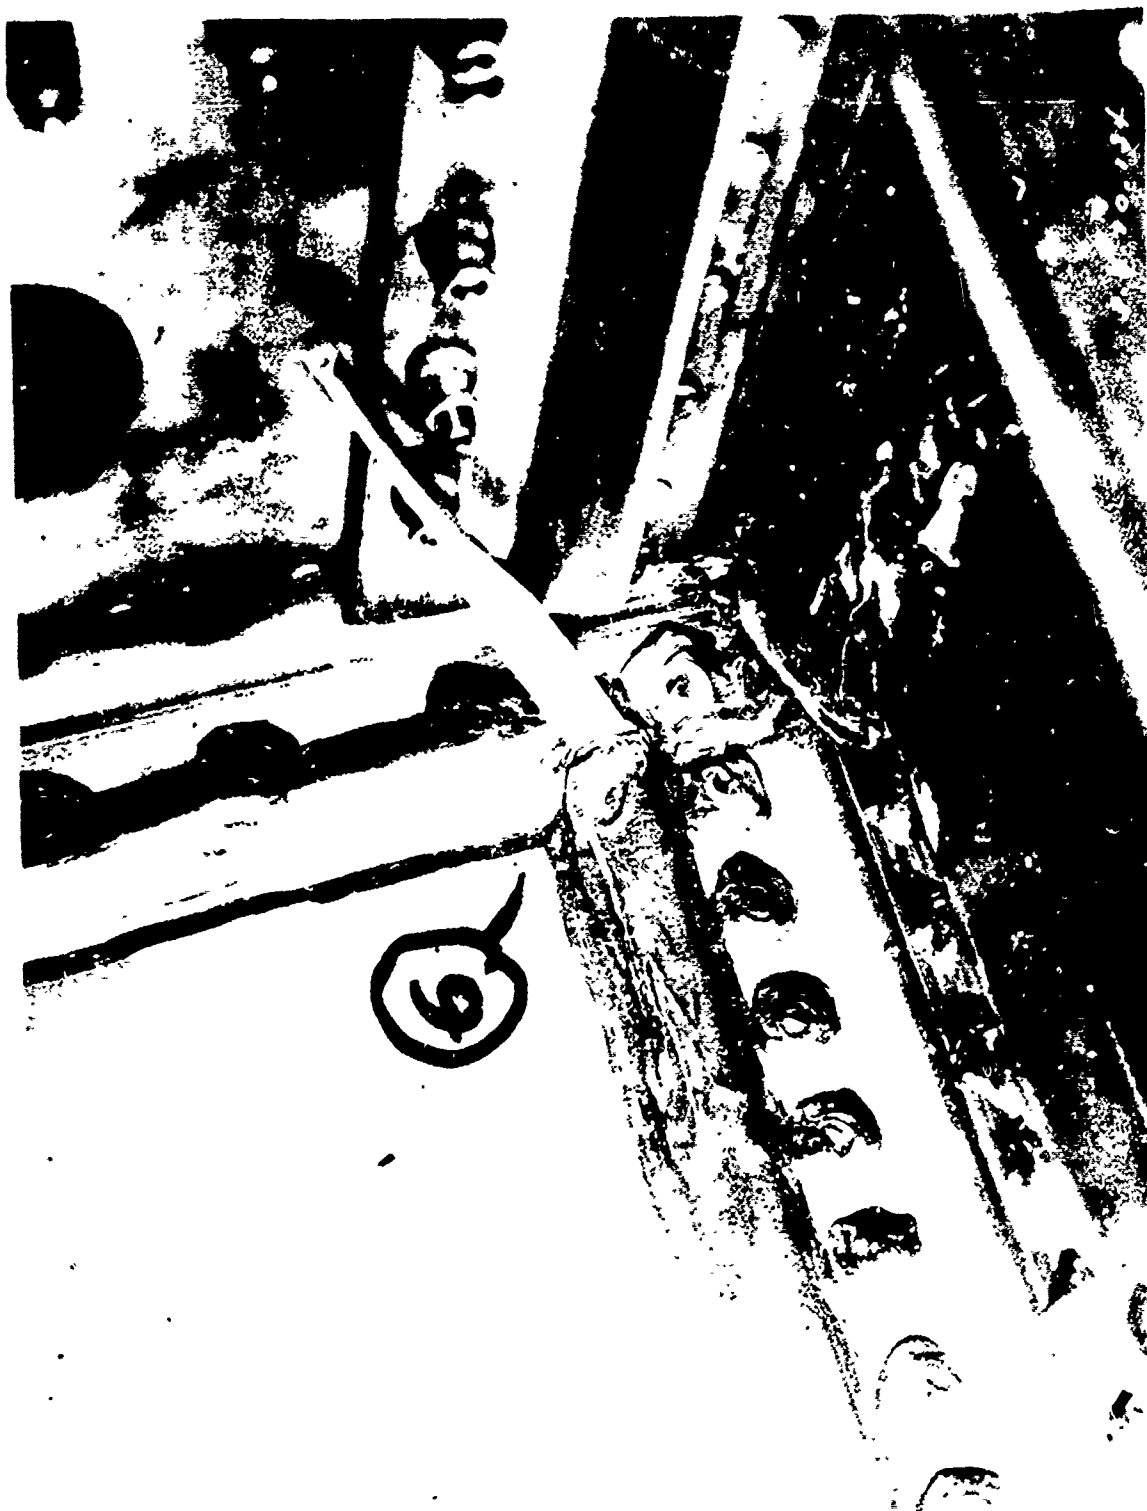
FIGURE 16 - CRACKED FILLET AT CENTER RIB OF TANK NO. 2

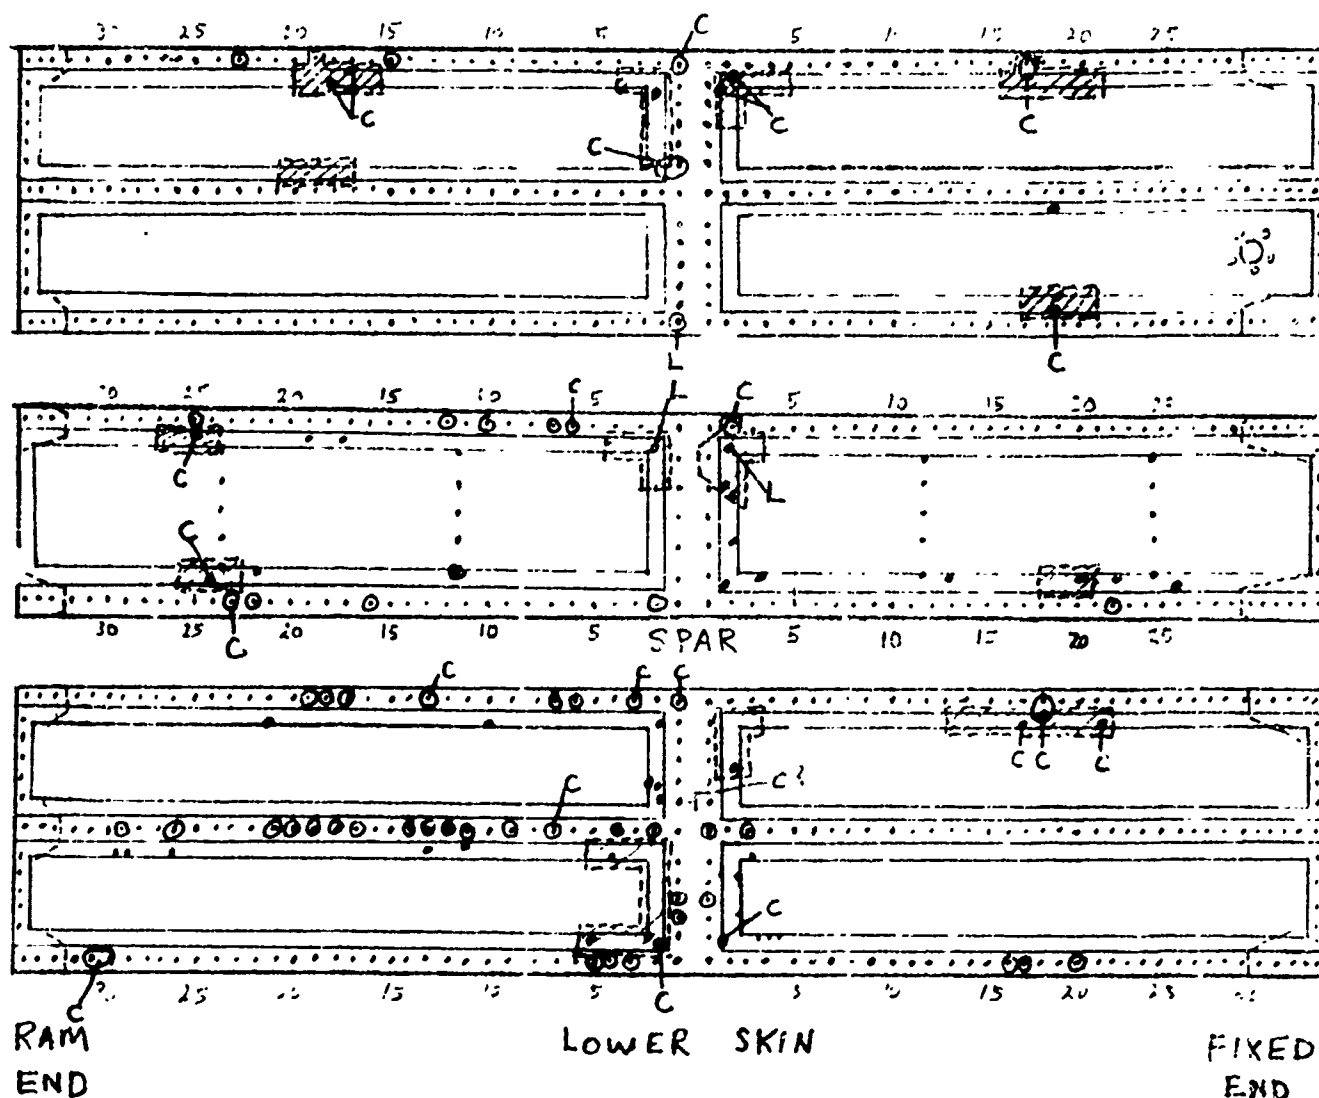
A "C" POINTING TO ABOVE AREA INDICATES A SMALL LEAK WITH
CONTINUOUS BUBBLING.
AN "L" INDICATES A LARGE LEAK WITH VIGOROUS BUBBLING.

TANK NO. 1 INTERIOR LEAKAGE ANALYSIS CONDUCTED AFTER 12
ENVIRONMENTAL CONDITIONING CYCLES. ANALYSIS CONDUCTED USING 5 PSIG
NEGATIVE (VACUUM) PRESSURE IN TANK WITH WATER LAYER
ON INTERIOR TO VISUALLY INDICATE LEAKAGE BY BUBBLING.

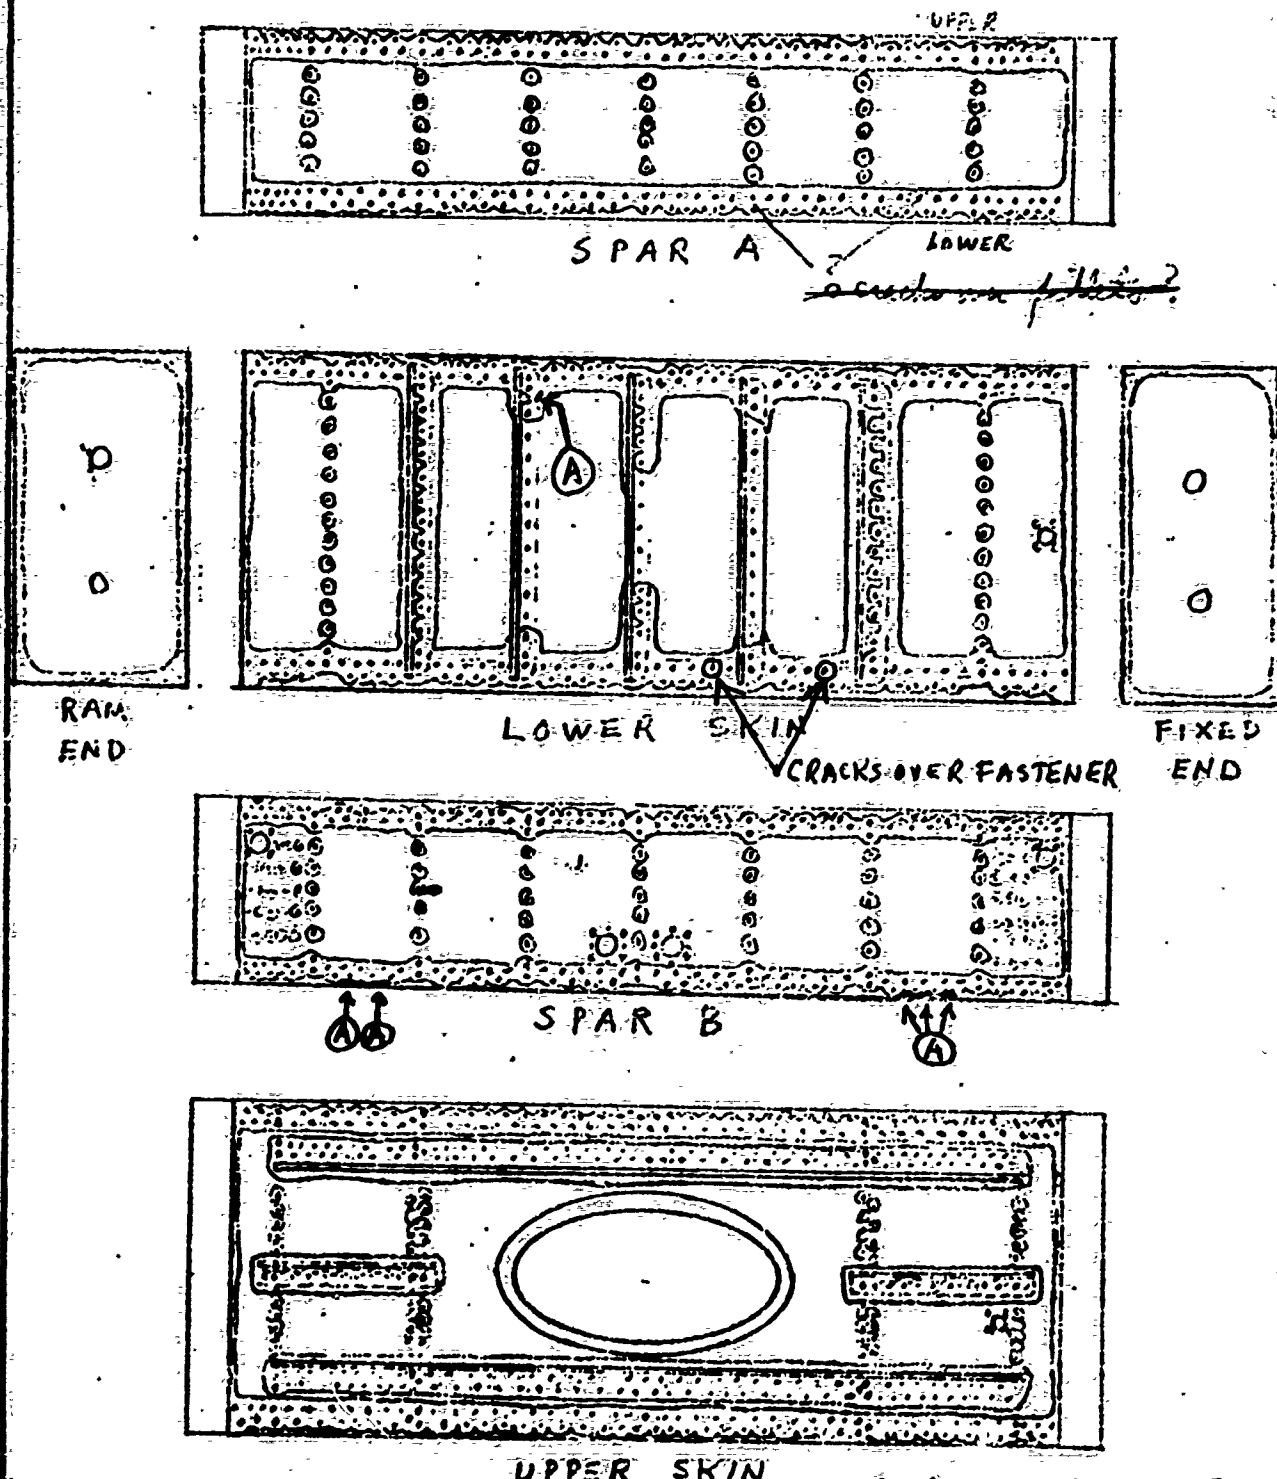
(A) VERY SMALL FILLET CRACKS

*CRACKS IN ADDITION TO THOSE SHOWN IN DATA SHEET NO. 3-3

CALC.			DESIGNED	DATE	TANK NO. 3 INTERIOR VIEW SHOWING ADDITIONAL* CRACKS AFTER 1500 P.T. CYCLES + 500 HOT CYCLES	
CHECK						
A.S.						
APR						
CONTRACT NO.					DATA SHEET NO. 3-5	B-5

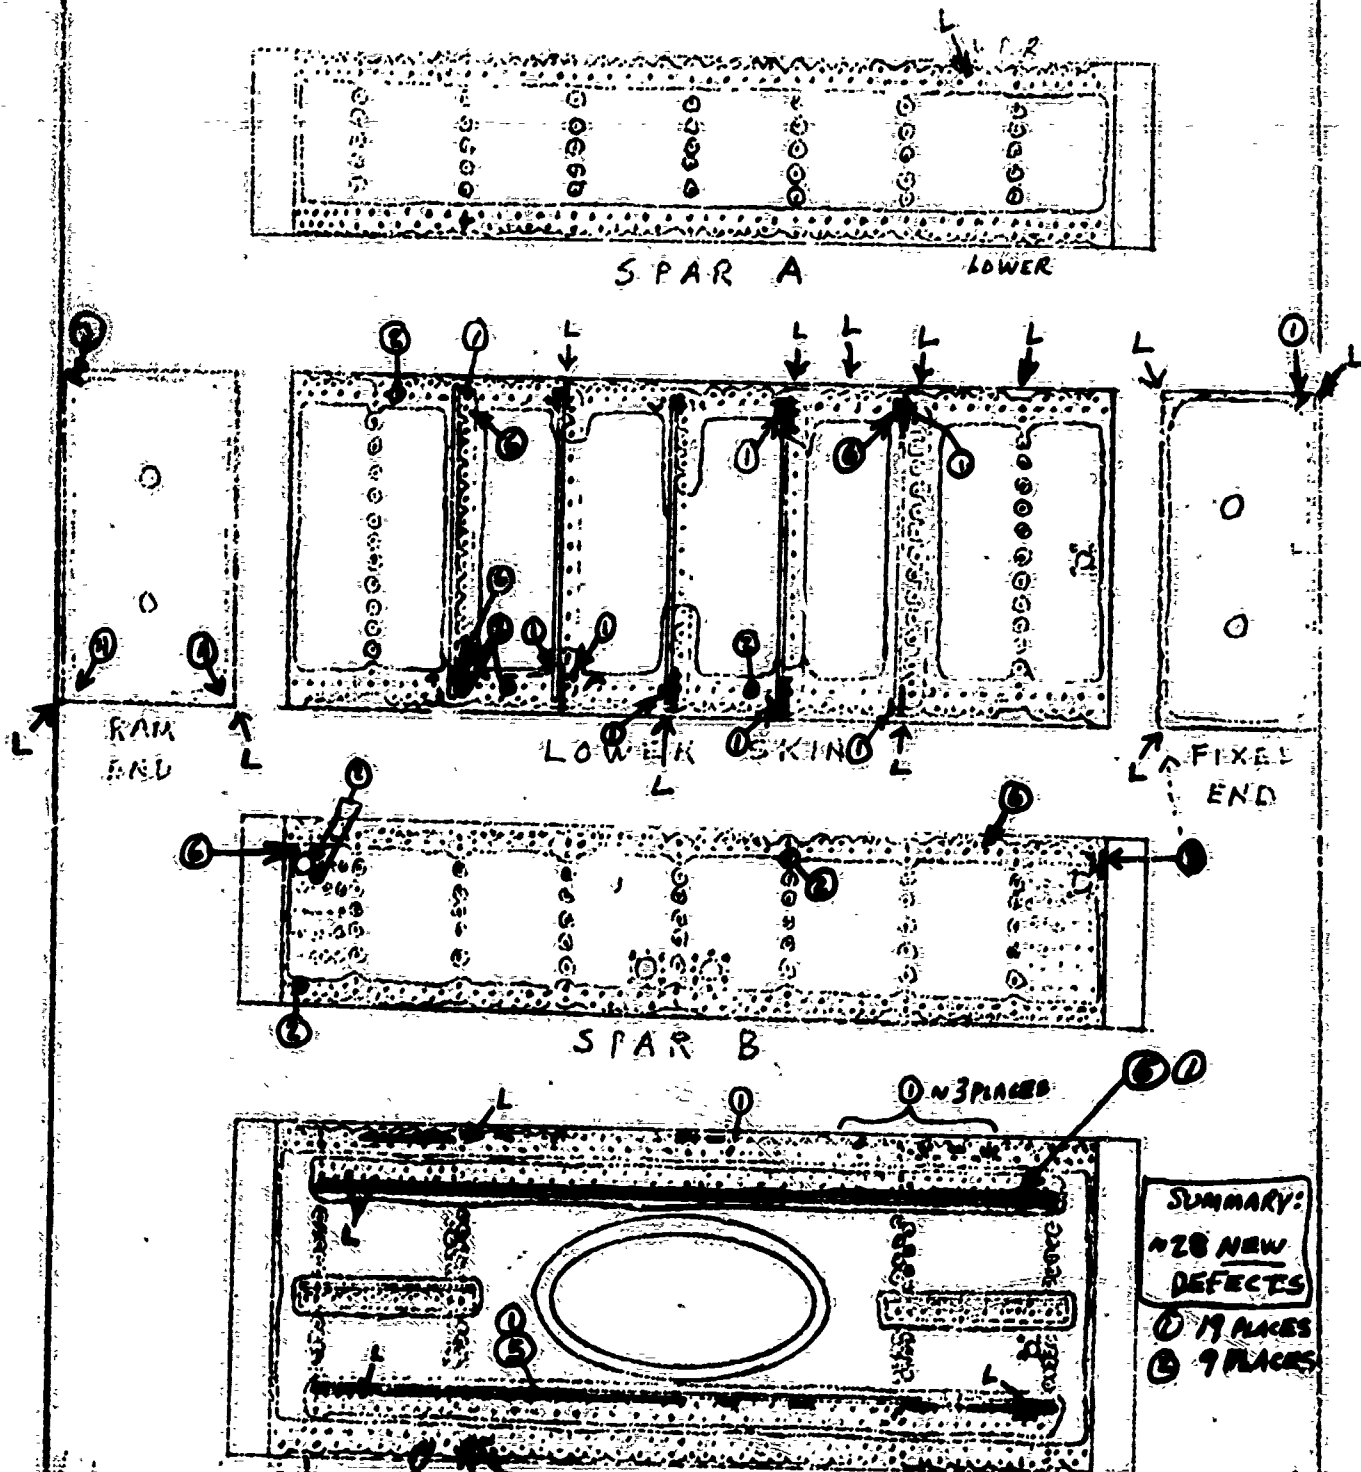
SUMMARY:
 428 NEW DEFECTS
 ① 17 PLACES
 ② 9 PLACES

- ① NEW CRACK THIS TEST
- ② SEALANT OVER FASTENER TORN
- ③ NEW CRACK IN ORIGINAL SEALANT
- ④ SOME EVIDENCE OF LOSS OF ADHESION OF REPAIR SEALANT TO ORIGINAL SEALANT
- ⑤ FILLET CRACK ALONG STIFFENER
